## ***STURMPANZER SPOTTERS GUIDE***

[Stu.Pz.Abt. 216]

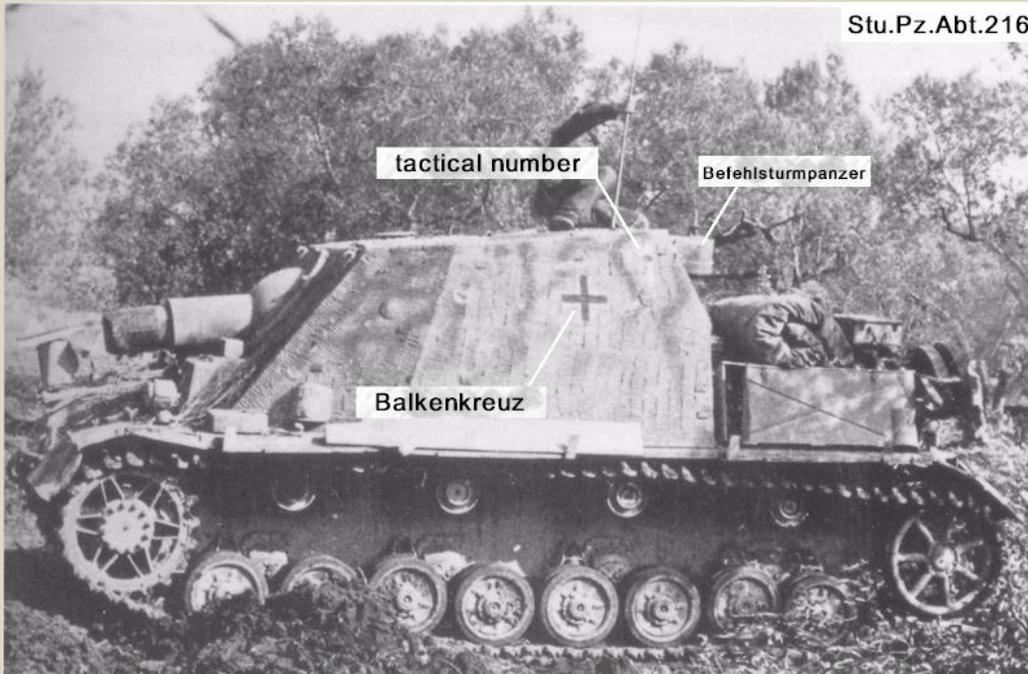
16 . 2

A Series 3 Sturmpanzer in Italy. This is a befehlsturpanzer. Since it has a tactical number of 1 instead of a roman numeral, it is a company command vehicle.

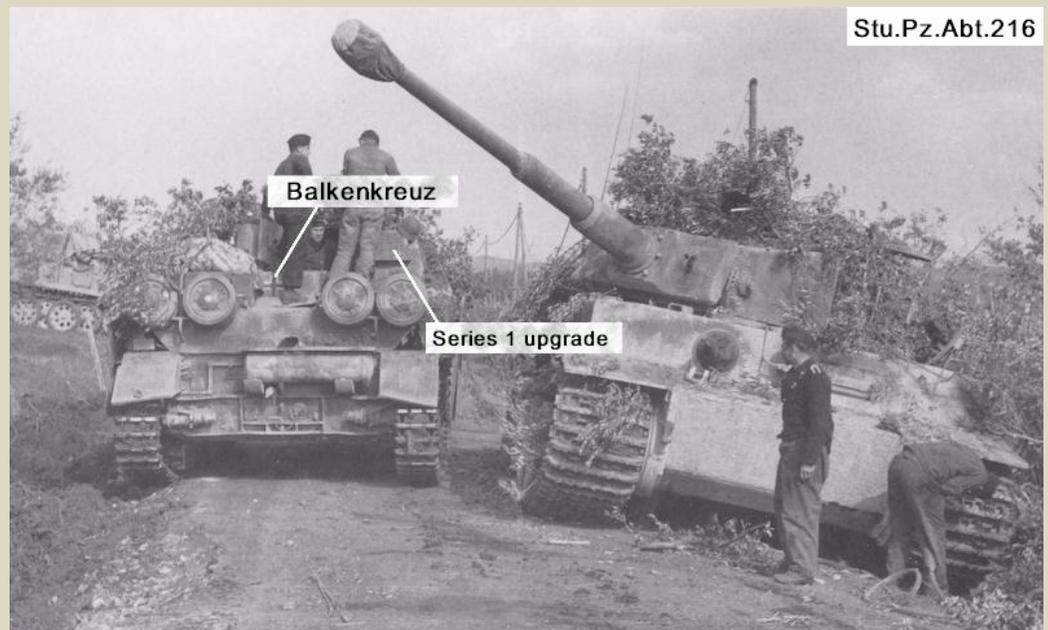
34 . 1

This is an upgraded Series 1 as noted by the armored air intakes. It has a Balkenkreuz on the rear, Zimmerit and camo typical of the battalion in Italy. Also note the cargo on the rear deck. This was typical for the battalion during the early period in Italy.

A Series 1 upgrade with a Balkenkreuz but with no tactical number. Note the tarp and the cargo on the back. I believe this to be the same vehicle as in image 2 above.

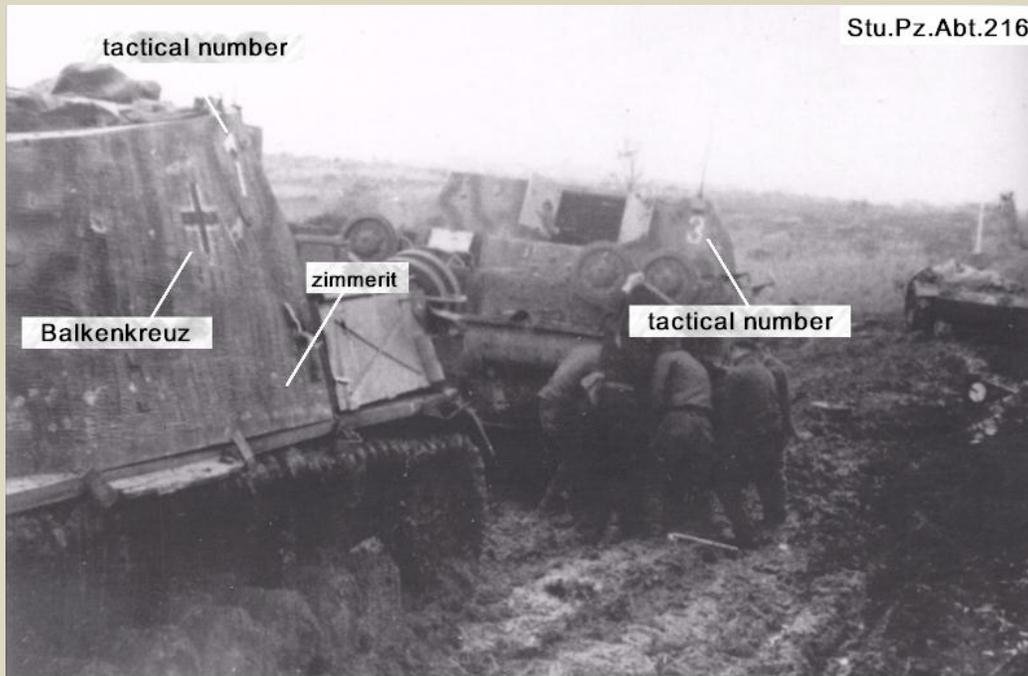
78 . 3

Two Series 3 Sturmpanzer. Note the location of the Balkenkreuz, slightly higher and back of center. Also there are tactical numbers located on the top corner of the side and also on the right side of the back just under the antenna mount.

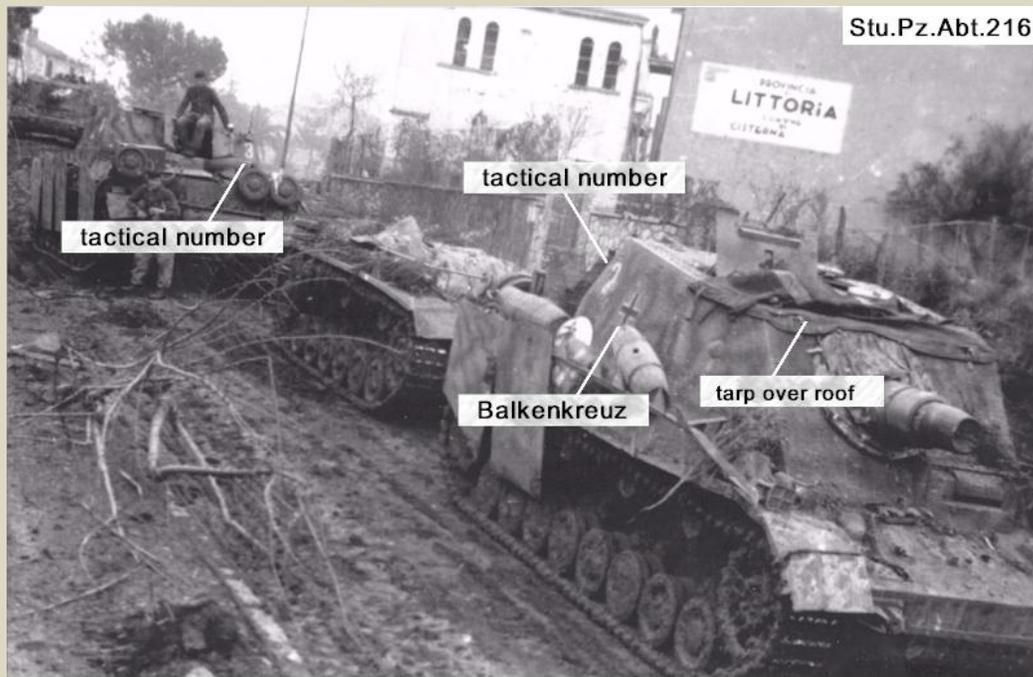
80 . 3

The Sturmpanzer in the foreground is a Series 2 as indicated by the drivers visor port. This Sturmpanzer has the typical markings as well as crews items stored on the side. Also notice the tarp on the roof of the Sturmpanzer. A tarp was used frequently by Sturmpanzers of the battalion in both Russia and Italy.

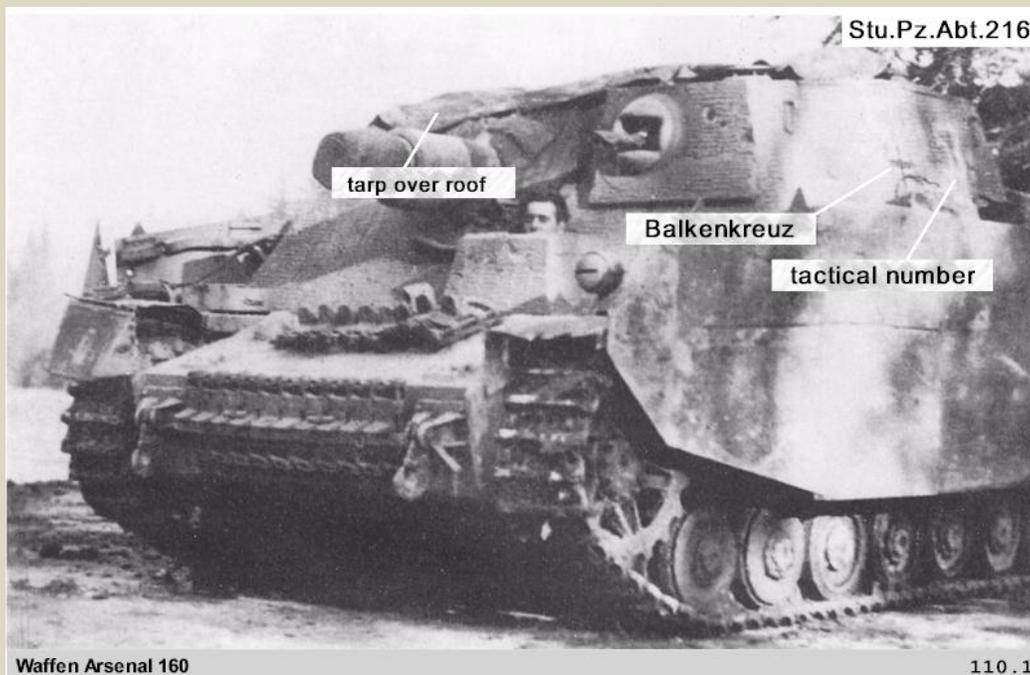
110.1

A Series 4 Sturmpanzer in Italy with typical markings of the battalion along with a tarp. Notice the number is 53 which indicates this might be from the 4<sup>th</sup> company. Only the 216<sup>th</sup> had a 4<sup>th</sup> company if only for a short while. It also has steel wheels in the two forward positions.

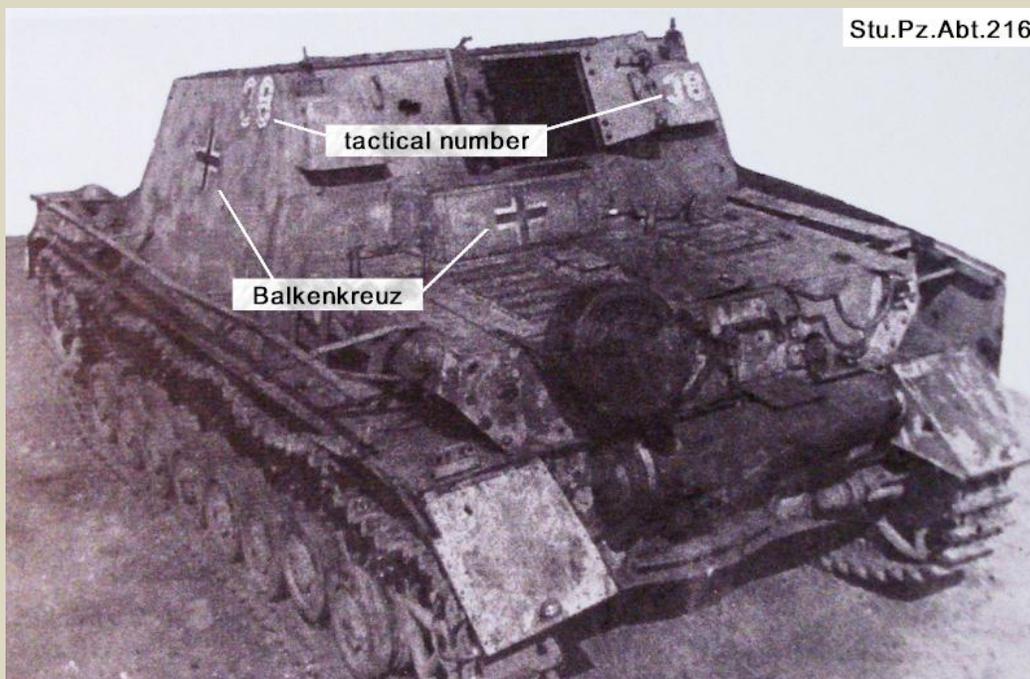
156.1

A Series 1 Sturmpanzer in Russia. Note that during their period in Russia, the battalion used the same markings and in the same locations as in Italy. However, the style of the numbers changed.

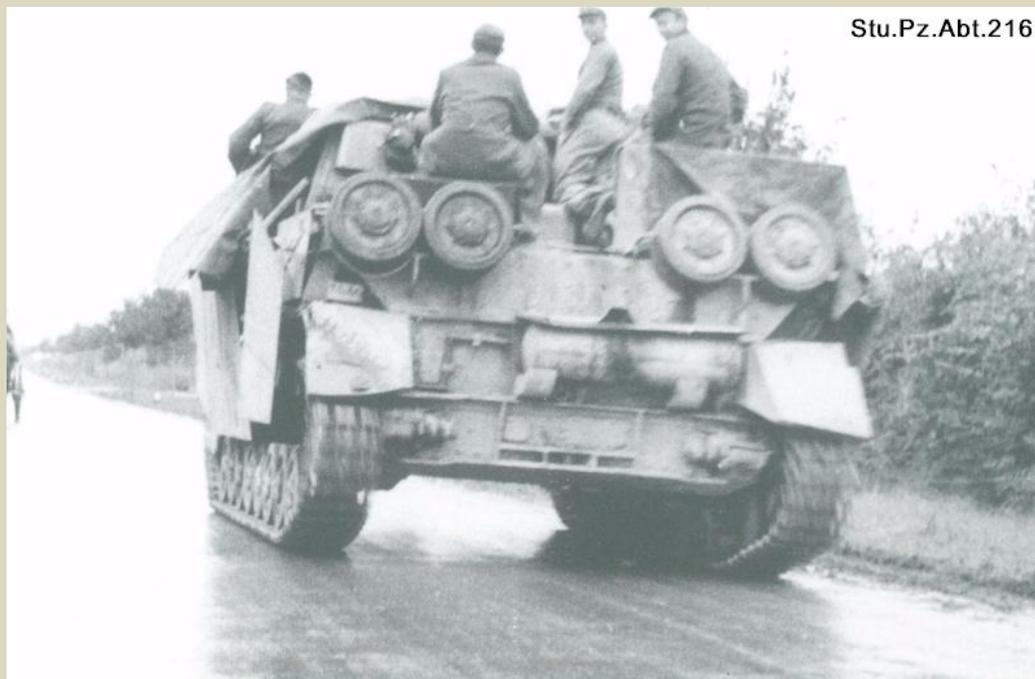
163.1

Series 1 upgrade in Italy. No markings are visible but the tarp and cargo on the rear engine deck are visible and typical of the battalion.
