STURMPANZER SPOTTERS GUIDE

[Stu.Pz.Kp. z.b.V. 218]

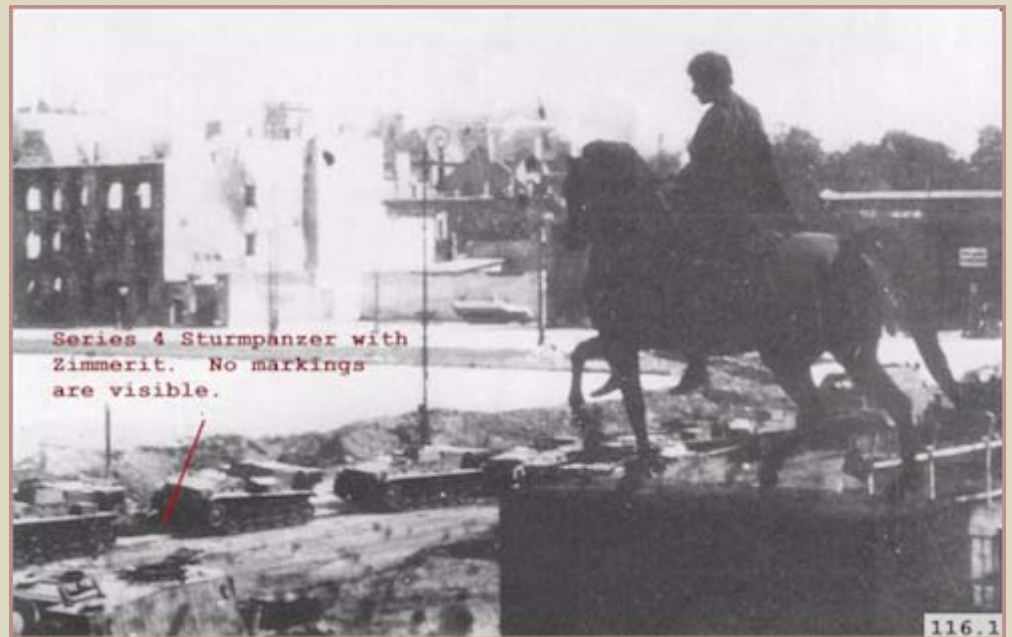
Figure 5.

Sturmpanzers along with Sturmgeschütze and BIV's of Pz.Abt.302(Fkl) in Pilsudski Square. They are passing in front of a monument of a mounted Prince Jozef Poniatowski.

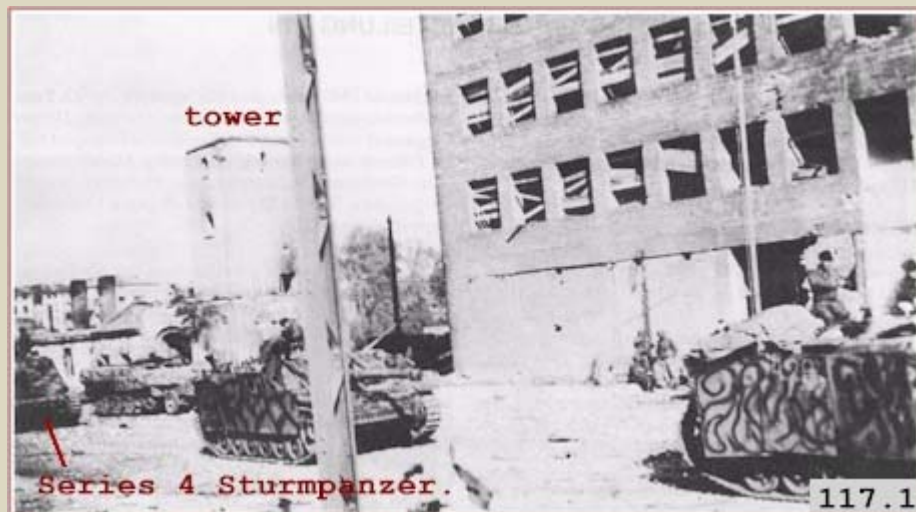
Figure 7.

Sturmpanzer and Sturmgeschütze in the western part of Warsaw, an area known as “Mokotow”.

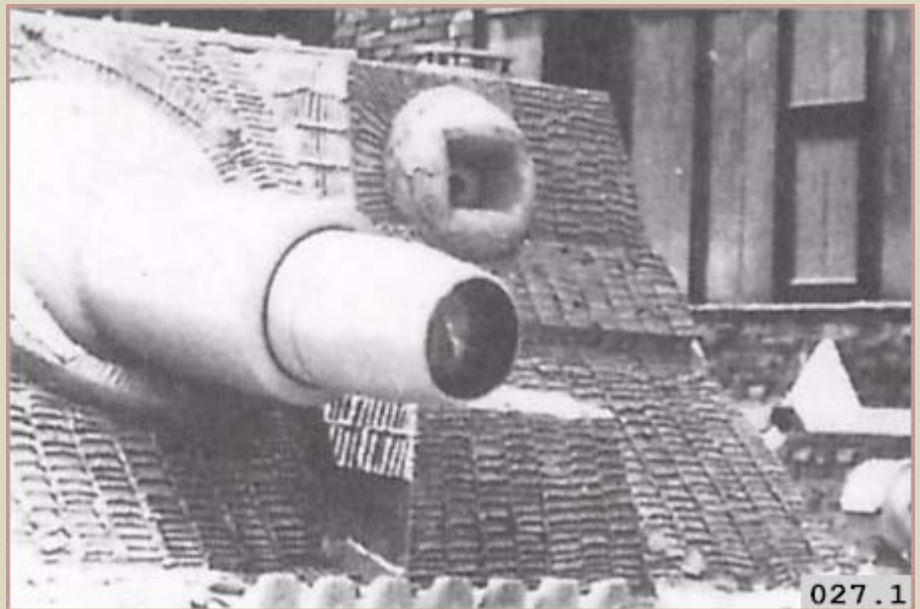
Figure 10.

Sturmpanzer with course Zimmerit.
