US MILITARY INTELLIGENCE REPORT

ETO ORDNANCE TECHNICAL INTELLIGENCE BULLETIN #27

SUBJECT: Czech Light Tank, Pz. Kpfw. 38 (t), with Turret Mounted Tank Gun, 2 cm KwK 38 (German)

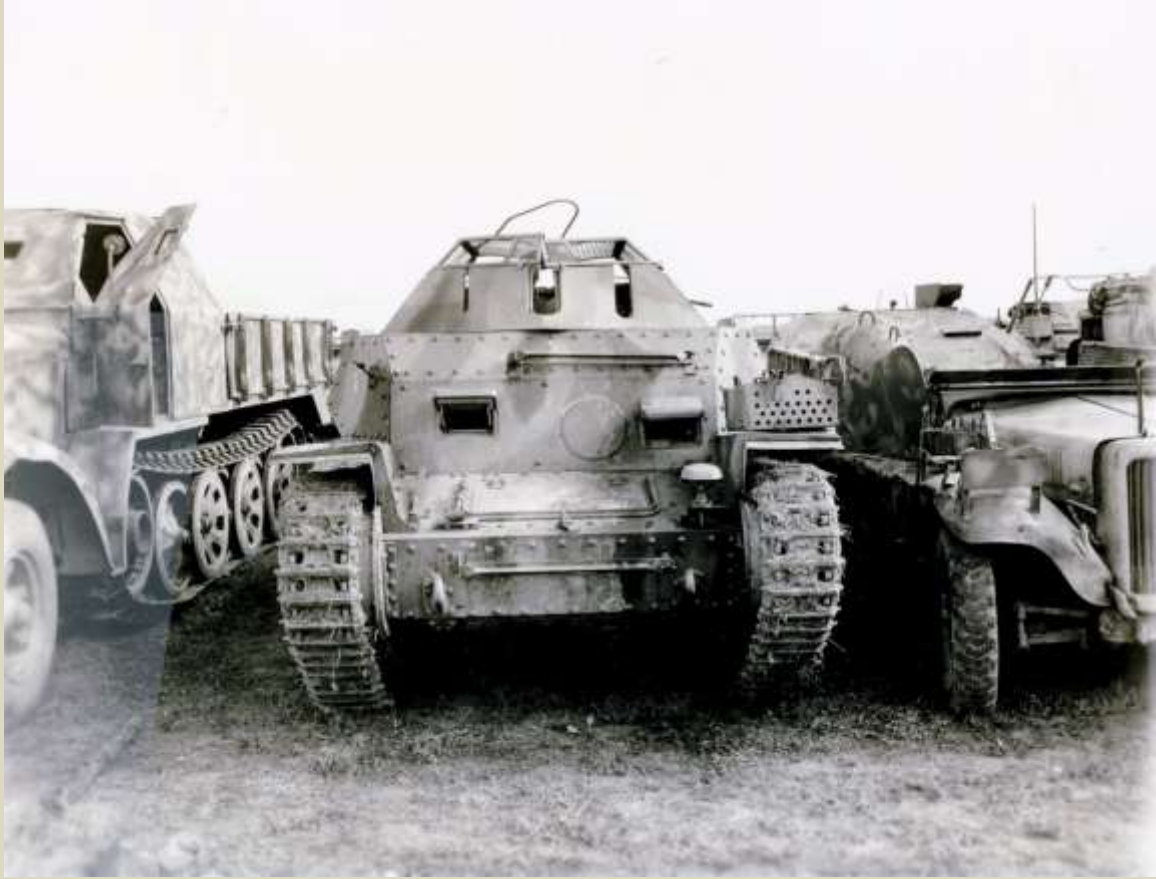
Photo No. 1 – Front view.

The turret is six-sided, the front plate being 31 mm (1.22 in.) thick and the side and rear plates 9 mm (0.35 in.) thick. The top of the turret is covered with a two-piece anti-grenade screen which opens outward to the sides.

The 2 cm KwK 38 gun is mounted at the center of the turret and has a 7.92 mm M.G. 42 machine gun mounted co-axially on the left. Traverse of the turret is 360° and is manually controlled by the gunner.
